SERVICE DEPARTMENT BULLETIN

BULLETIN #91129

GENERAL CLASSIFICATION: Control Deck Repair
SPECIFIC SUBJECT: NES-CPU PCB (PART NO. 22667) 06 VERSION MODIFICATION

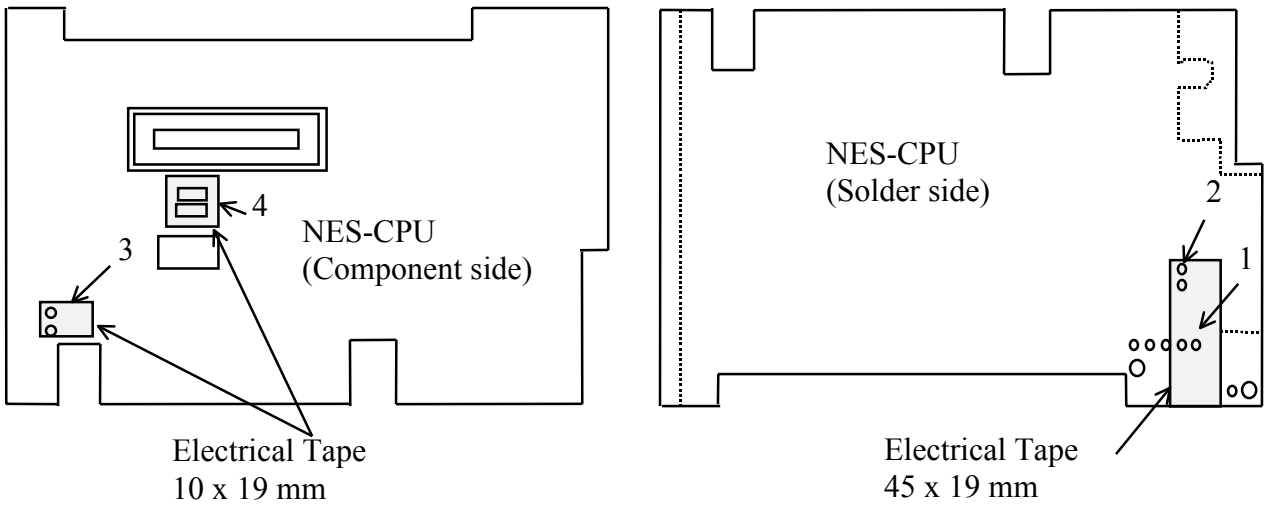
There is a possibility that circuit traces of the NES-CPU PCB 06 version will touch the upper or lower shield and cause a short circuit problem. To prevent this possibility, electrical tape must be applied to three locations on the PCB (refer to the figures below). For this application, the electrical tape should be rated UL-94 V-0.

Locations involving the problem:

1. Between the signal side trace of C33 and upper shield case.
2. Between the two through holes beside DA3, DA4, and upper shield case.
3. Between the four holes beside R3, R4, and lower shield case.
4. Between R9 and lower shield case.

Repair Action

If product is in or out of warranty, perform modification as necessary. **Do not submit warranty claims for this modification.**
